NEWSLETTER SPRING 2020

CTLAB
X-ray Computed Tomography

Central European Institute of Technology
BRNO | CZECH REPUBLIC

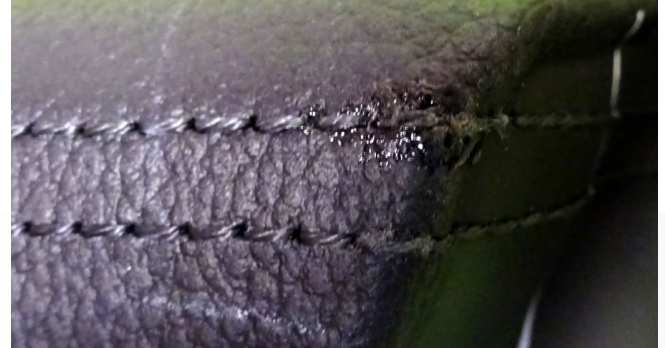
Figure 3: Leak in the armrest.

We recently addressed the problem of leakage through decorative stitching in the armrests for one type of Škoda car. The rubber imitation of leather armrests is stitched at the factory and the sewing is covered with a liner tape on the inside. The work piece is then placed on a plastic base, and the gap between is filled with foam. This foam seeps through some parts through the sewing and leaves visible shiny marks on the product surface.

Problem sections were excised and analysed using Phoenix v|tome|x L240 with a resolution of 20 $\mu\text{m}/\text{voxel}$, according to the size of the cut-out. Resulting CT data revealed two possible causes of leakage. The first one is the unwanted perforation of the tape, the second one is the deformed contact of the tape with the rubber, caused by the foaming process where the foam flows under the tape. The causal link is hidden in another monitored parameter, which is the thickness of the rubber material and subsequent tape repression, its damage and leakage.

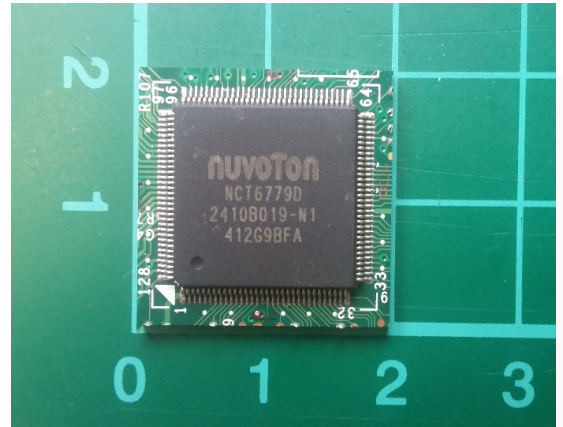
Figure 7: Measured chip.

In order to demonstrate the possibilities of this method, and at the same time the difference between classical CT, we carried out the analysis using the procedure of the desktop computer motherboard. Measurements were performed on the GE mixrome|x and the micro tomography station GE v|tome|x L240. Although laminography was performed with a better voxel resolution of $11 \mu\text{m}/\text{voxel}$ over micro CT $15 \mu\text{m}/\text{voxel}$, the comparison clearly shows that micro CT achieves significantly better results due to multi-angle projections. Laminography can thus be used on samples such as large printed circuit boards, where the micro CT would be limited by the resolution and often also by energy needed to penetrate the board in the transverse direction.

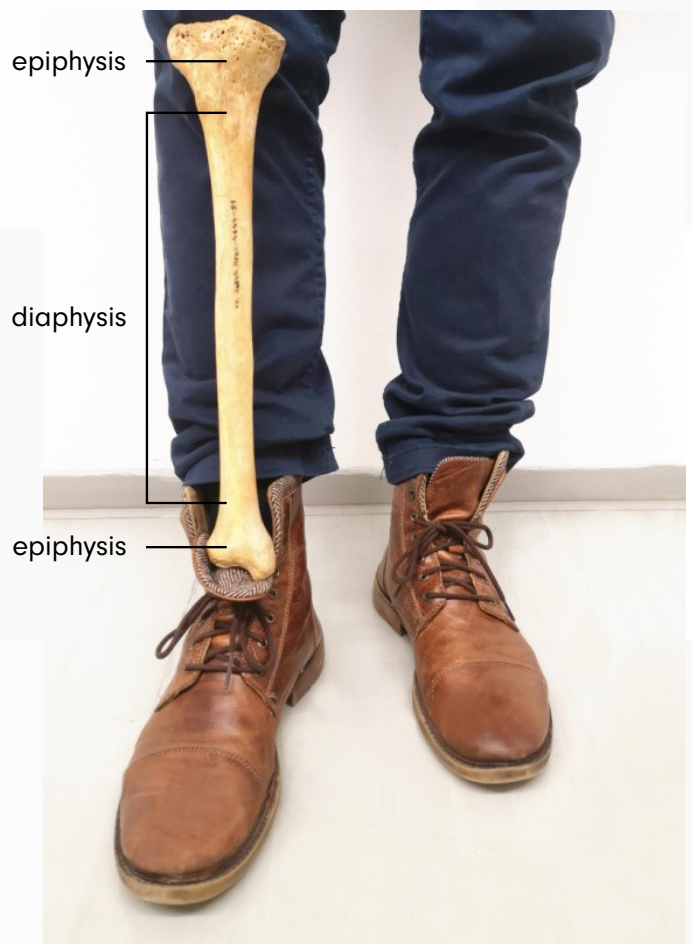
Figure 11: Picture of real tibia.

Intra-articular fractures of the proximal tibial epiphysis, also known as „plateau fractures“, are very complicated and require extensive experience to fix them. The treatment of these fractures is based on classification according to the extent of bone damage (AO classification) or related soft tissues (Moore classification). Despite advanced methods of diagnosis and appropriate treatment, the results of healing are not satisfactory.
