CEITEC
CTLAB

NEWSLETTER SPRING 2026

CT AS A TOOL FOR INSPECTING LARGE ADDITIVE PARTS

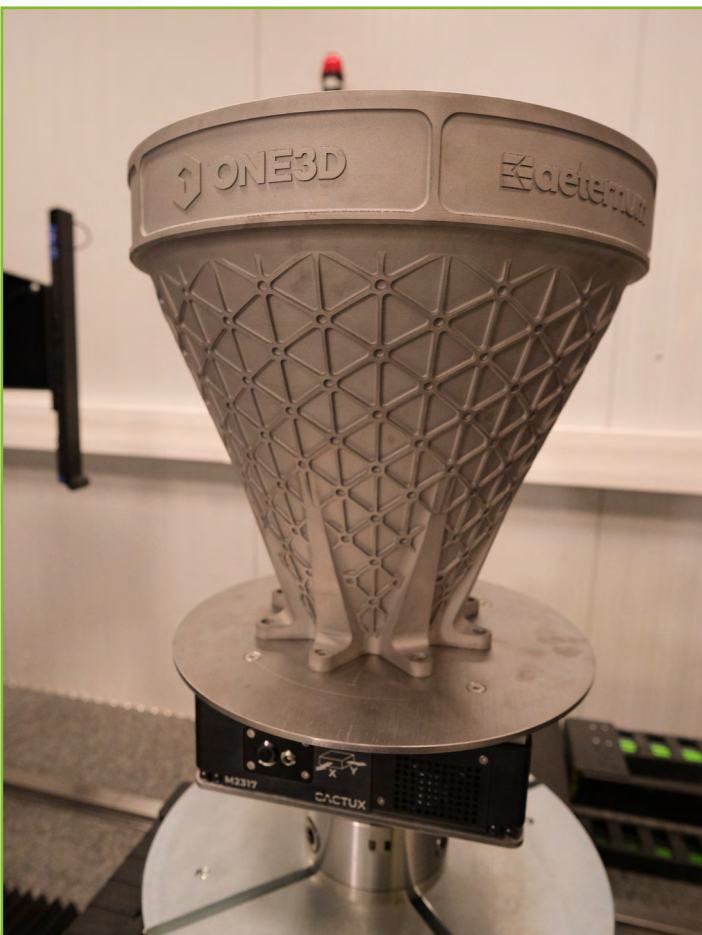
Figure 1: Photo of an additive part inside a CT system.

In this particular case, we have tested a part representing a jet engine part (Figure 1), manufactured on an EOS M400 device from Inconel 718 material at [ONE3D](#), a company specializing in metal 3D printing. The production itself took place in layers with a thickness of just 40 μm , with impressive total construction time of 85 hours. The resulting part stands out not only for the material used and the manufacturing complexity, but also for the combination of geometric elements, such as the wall thicknesses reaching a minimum of 2.85 mm, while the total diameter of the component is up to 370 mm

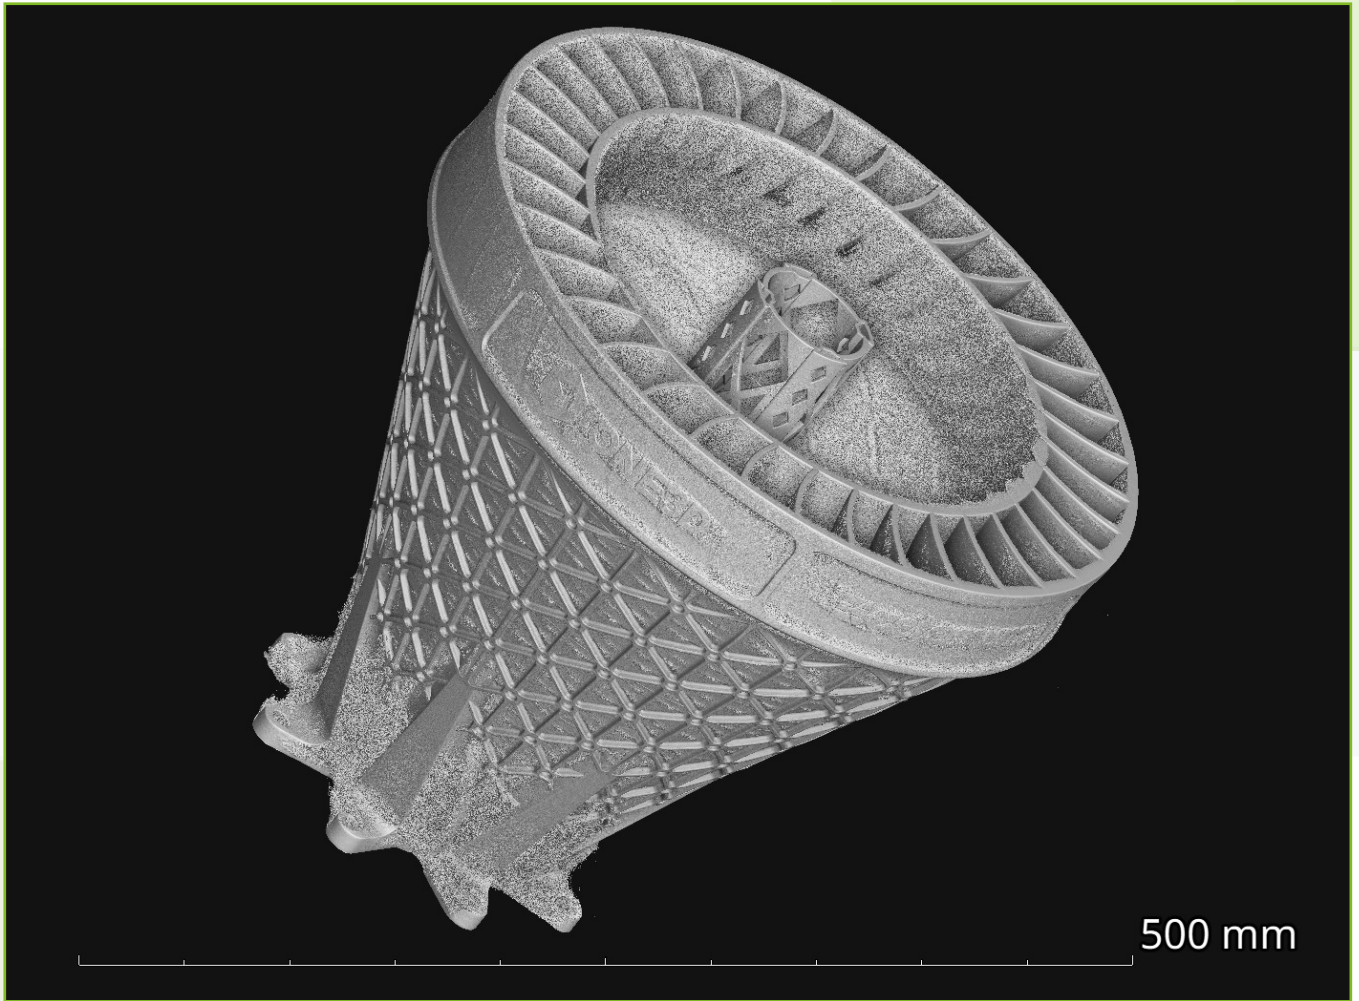
Figure 2: 3D visualization of the automatically detected part surface in the VGStudio MAX program environment.

As the limits of 3D printing metal parts are pushed, especially in terms of size and complexity, the demands on inspection technology for detecting internal defects or geometric deviations are also increasing (Figure 2). Thanks to its characteristics, the part became an ideal candidate for demonstrating the capabilities of our newly installed L450 CT system from [Waygate Technologies](#), which has a mini-focus tube with a maximum voltage of 450 kV and a power of 1,500 W. The quality of the resulting data was also improved by the patented [Scatter|Correct](#) technology, which uses anti-diffusion grid to absorb unwanted scattered radiation. The wide entrance to the CT cabinet and the built-in crane allow the handling of parts weighing up to 200 kg.

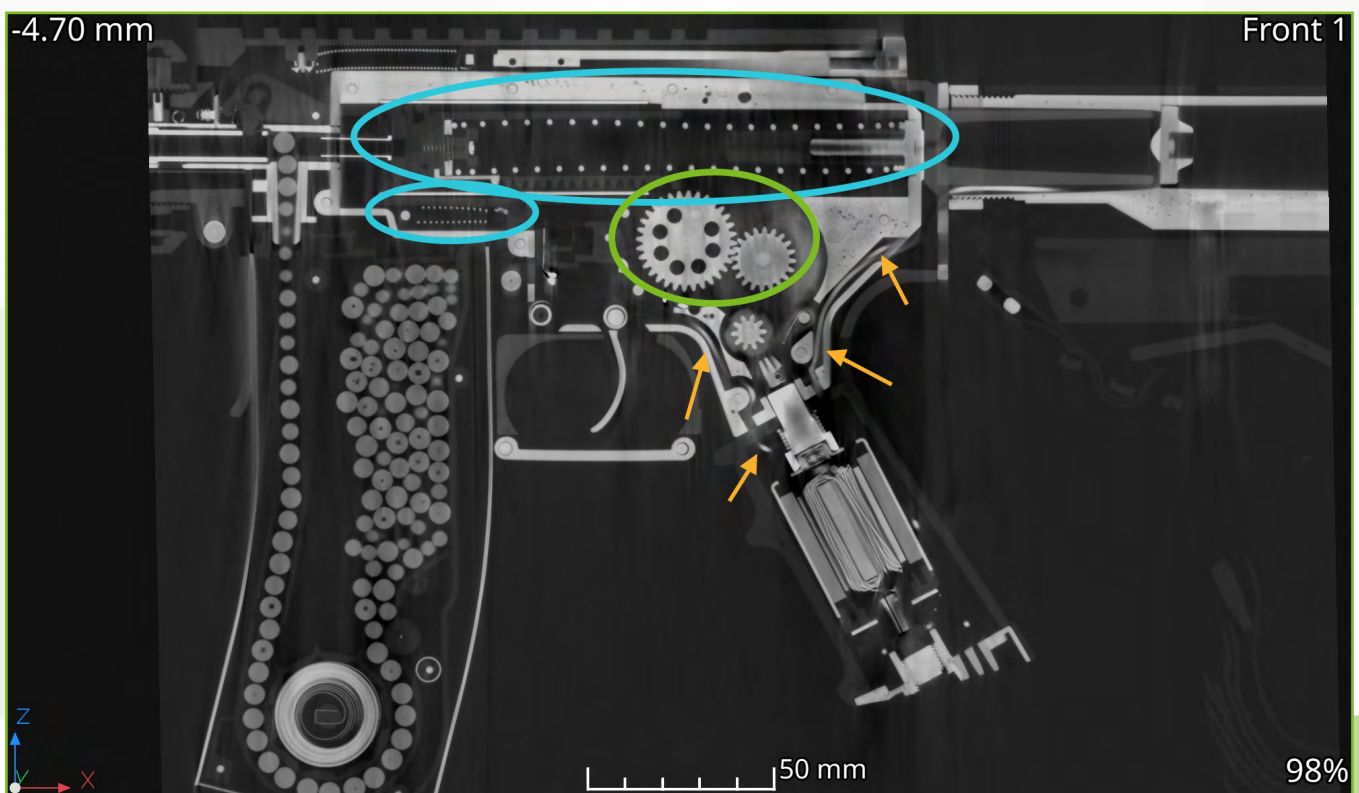
Figure 3: Tomographic section of the mechanical part of the weapon. Blue color shows the location of the springs, orange arrows show the wiring.

Using the example of a scan of this weapon, we can demonstrate the key applications of our devices, especially the inspection of the complete weapon assembly (see Figure 3). Thanks to CT, we can see the real position of the components without having to disassemble any part of the weapon. We were able to check whether the gears in the gears fit together correctly, whether the springs are not deformed, and whether the wiring leading from the electric motor to the weapon mechanics does not interfere with moving parts. At the same time, we focused on revealing hidden defects in the material, because weapon bodies are often die-cast, prone to the formation of pores. CT reliably detects this porosity (see Figure 4) and any cracks in the material, which could lead to a rupture of the part in a stressed area. Fine details such as the seating of the sealing O-rings and the alignment of the barrel with the chamber are critical for shooting accuracy.

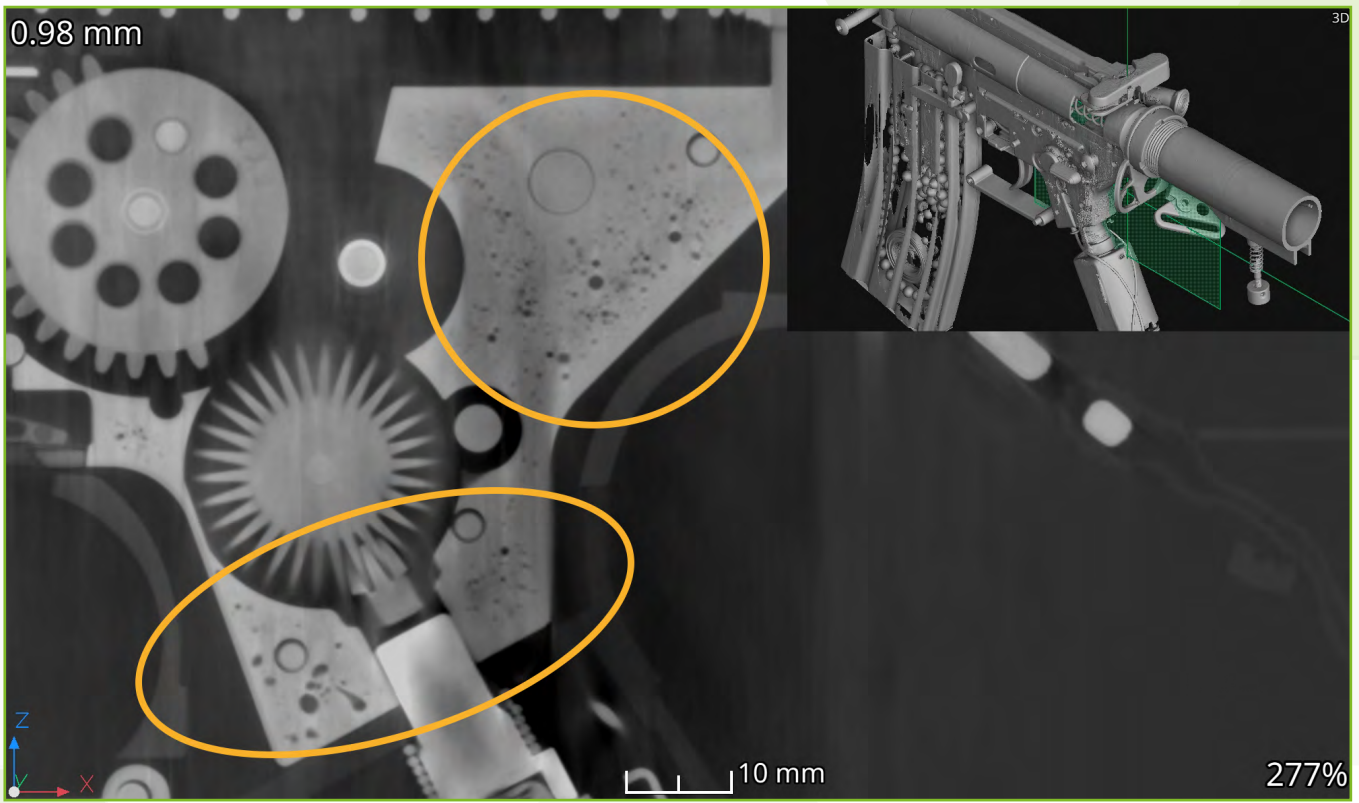
Figure 4: Porosity detected in the gun frame.

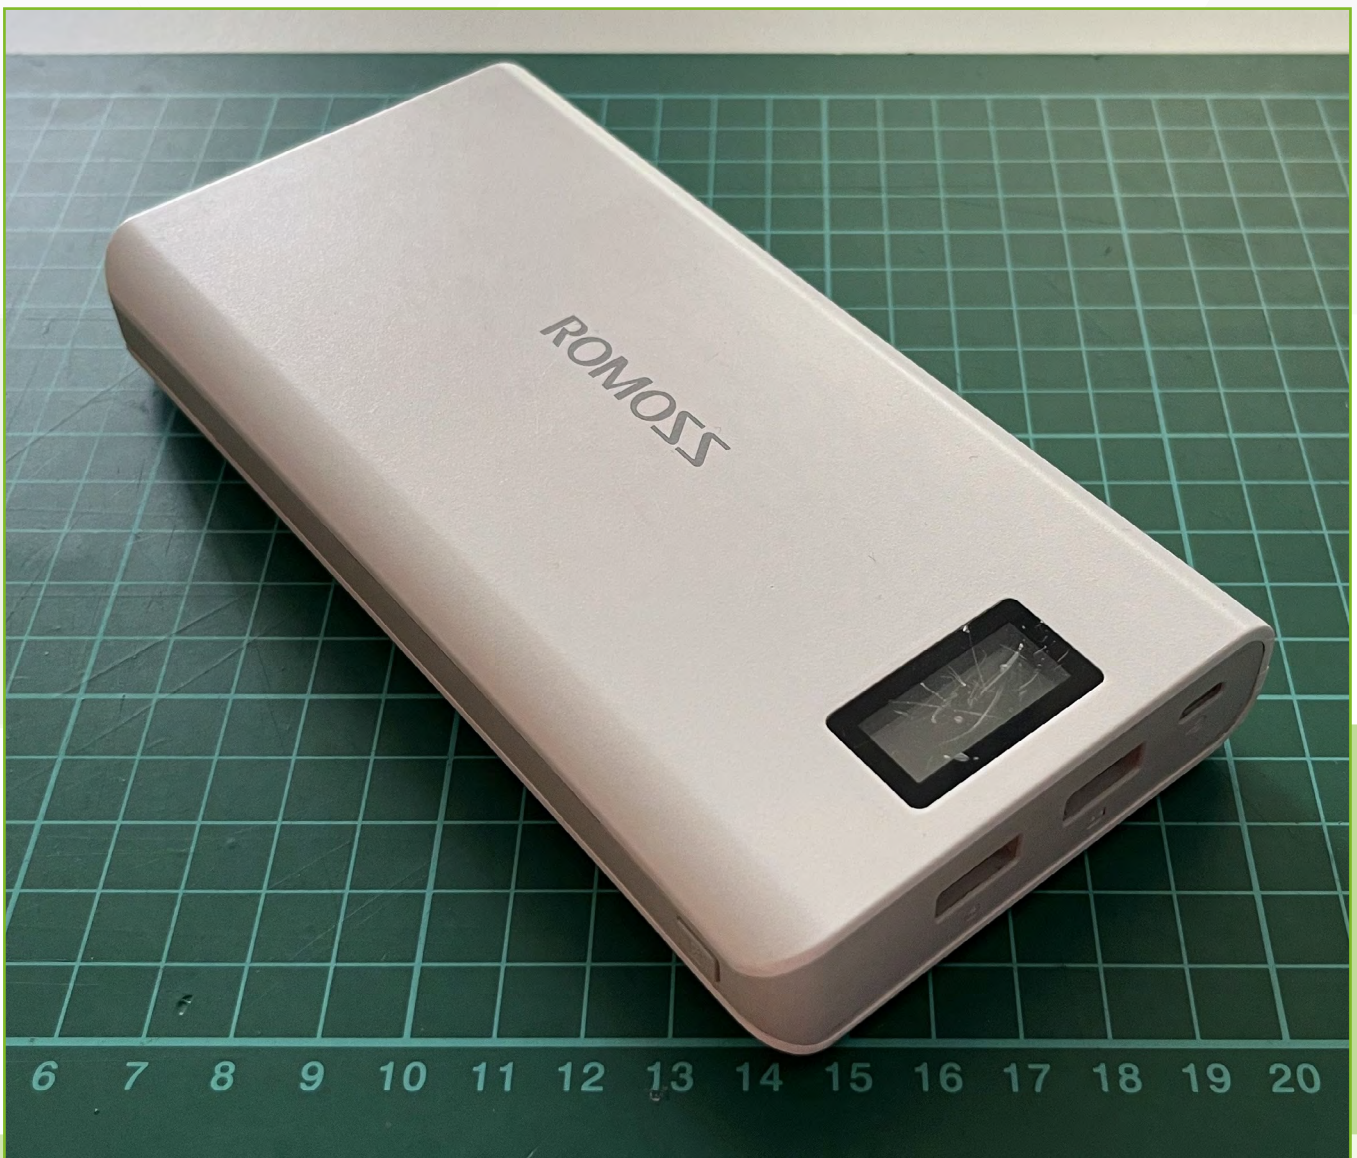
Figure 5: Photo of the analysed power bank. Only its middle part was scanned to achieve better resolution.

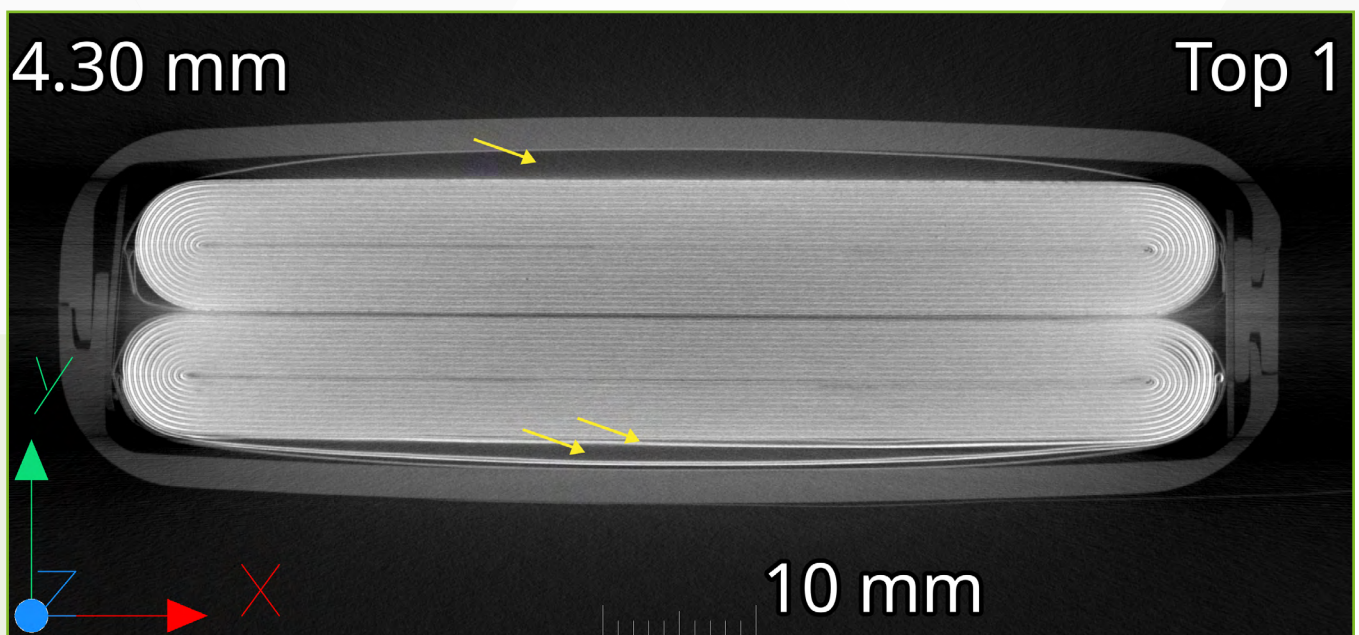
Figure 6: Tomographic cross-section of a damaged battery with two prismatic cells. The upper cell shows swelling of the casing. The lower cell shows delamination of the two outer electrode layers. The swollen areas are marked.

An illustrative example of battery system diagnostics is the case study of an expanded power bank. A tomographic section (Figure 6) captures a device integrating two prismatic cells that remains electrically functional despite significant volumetric expansion. While standard electrical testing would misclassify this unit as operational, 3D tomography reveals a severely compromised internal architecture characterized by interfacial delamination.

The obtained tomographic data, in addition to the visualization itself, also allows us to select a suitable place for subsequent destructive analysis, which would help to determine the cause of the observed degradation. Delamination can be caused most often by gassing due to electrochemical decomposition during repeated charging and discharging of the cell, thermal stress or simply aging. Another possible cause is mechanical fatigue of the material. Both cases can lead to internal short circuits and pose a safety risk.

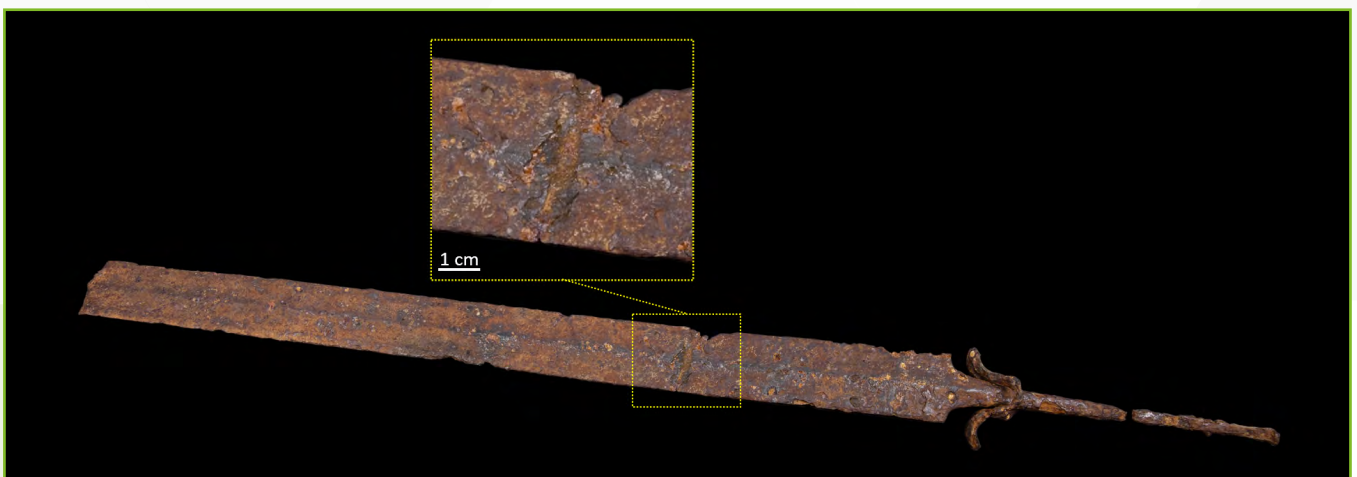
Figure 7: Late Iron Age sword before conservation with traces of pitting corrosion and a secondary defect (marked yellow).

In the initial inspection the sword exhibited traces of pitting corrosion and a defect caused by an external intervention (Figure 7). However, the actual extent of corrosion and a real condition of the iron core were revealed only during the CT analysis, as unexpected cavities were discovered throughout the length of the object (Figure 8). On the other hand, no decorative techniques or marks were found. This information will substantially affect future manipulation, as well as the extent of desalination. Moreover, the state of the sword before conservation will remain documented in detail for future reserachers.

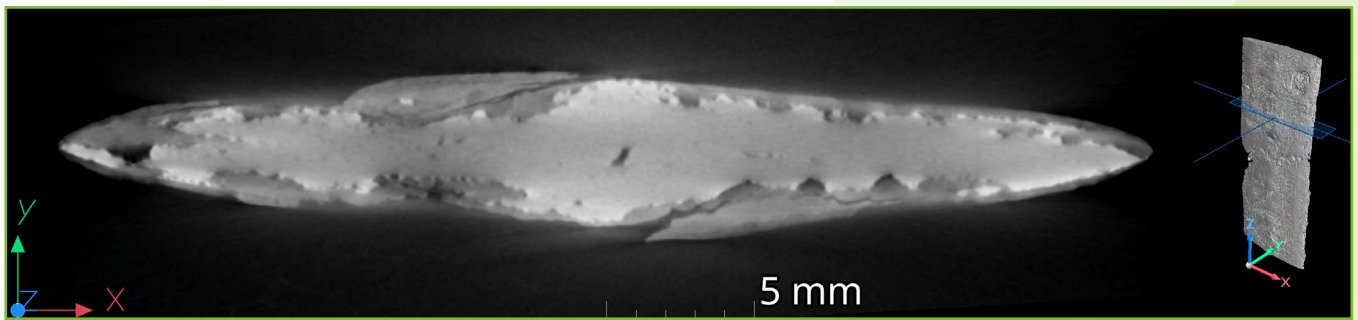
Figure 8: Tomographic cross-section of the sword blade. The iron core (in lighter shades) is heavily damaged with two visible delaminations of corroded material (yellow arrows) and an unexpected cavity in the center of the object (red arrow).
